## FACILITIES ASSESSMENT AND DEFERRED MAINTENANCE CAPITAL PLANNING REPORT

2011

SHWGROUP

SHW Group, in conjunction with the Michigan Technological University Facilities staff, performed a high-level facility condition assessment of all campus buildings in May 2011.

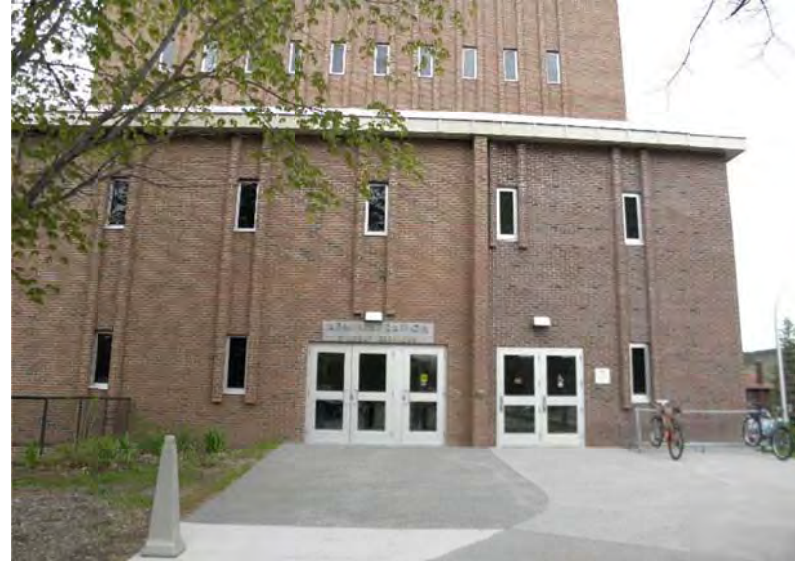
- Transformer is dust covered-needs cleaning; breakers have not been tested in 20 years, need testing and replacement of trip mechanism.

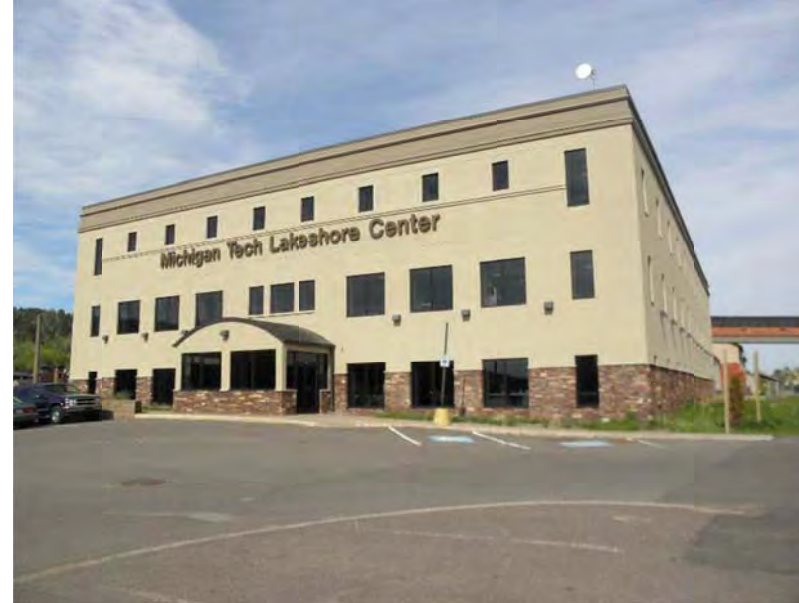
- Original building dates from early 1900's as a warehouse use.
- Building was extensively remodeled in 2009, inside and out.
- Sealant joints between EIFS and stone sills are at End of Useful Service Life. EIFS building joints are at End of Useful Service Life
- Damage to EIFS observed, repair.
- Exterior doors at rooms 114 and 121 are missing thresholds. Replace thresholds.
- Areas observed where sections of perimeter concrete walkway have heaved upward. Remove and replace heaved concrete.
- Geo-thermal system installed in 1991. The ground water temperature has begun to increase within the system and may need to be dealt with in the future. ASHRAE life expectancy for water-to-air heat pumps is 20 - 25 years. The ground water temperature increase should be evaluated by an engineer.

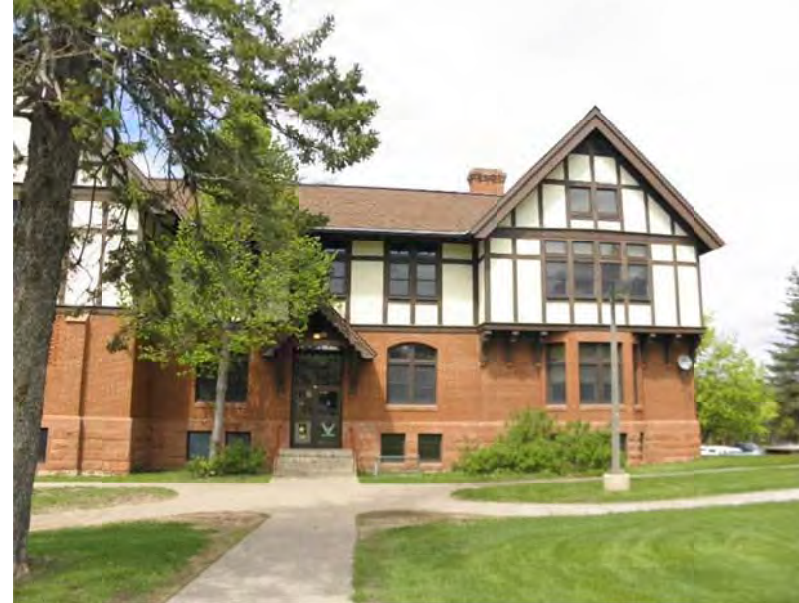
- Reheat coils are plugged. Provide air and water side inspection.
- Replace attic AHU – at end of useful service life.

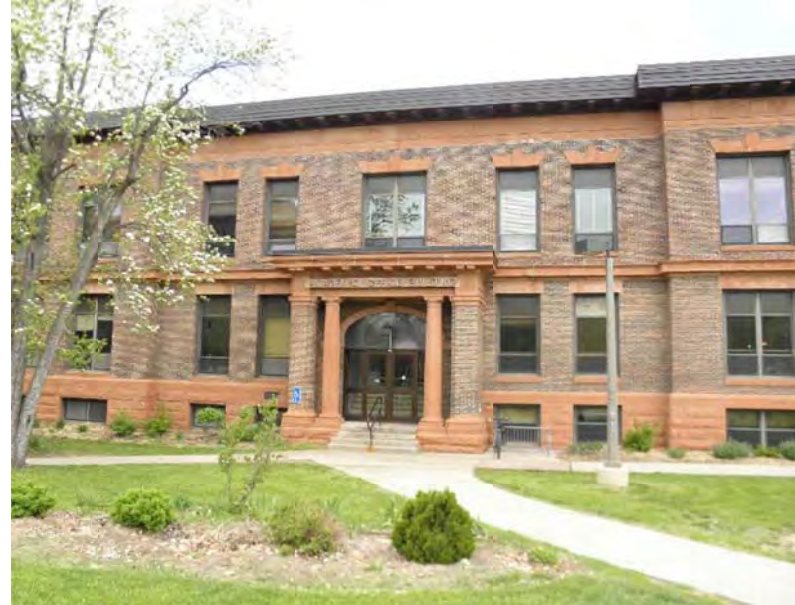
- Piping is at End of Useful Service Life.
- Need to address control issues and zoning in North wing. AHUs need to be replaced in next 5 years.

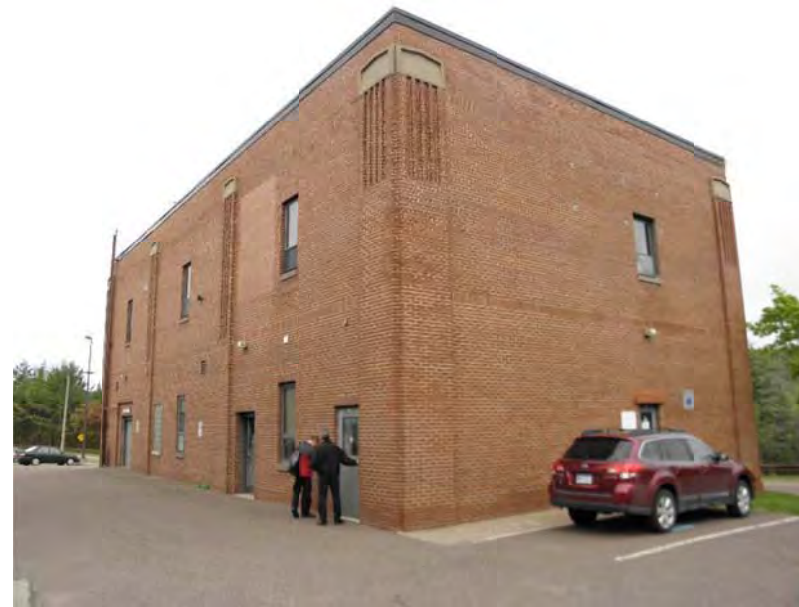
- Need to add strobes and replace Siemens FA panel with EST.
- Basement transformer and disconnects need to be replaced.
- No elevator.

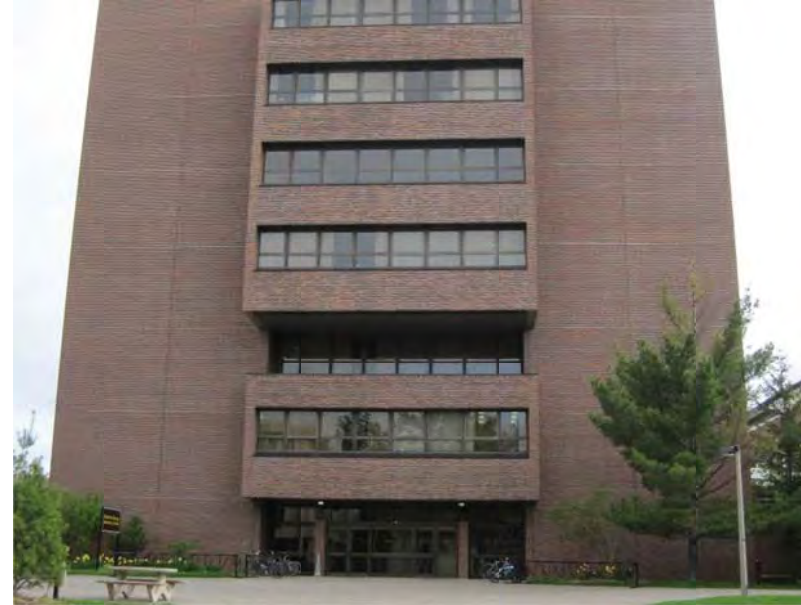
- Building in general is aging predictably and showing wear. Building is due for modernization.
- Classrooms are aging predictably and showing wear. Classrooms are due modernization to continue top instructional delivery.
- Active leak at northwest stairway. EPDM is beyond End of Useful Service Life.
- 2007 roofing membrane isn't adhering to roof.
- Water in pillbox of sub-basement.
- Glazing in classroom 427 has moisture @ sill.
- Rubber nosing is deteriorating under heavy use. Nosing at the End of Useful Service Life.
- Provide exit lighting in classrooms.
- Provide code compliant fire alarm system.
- Provide power operated door switch.
- Path of travel in SB34 exceeds code limits.
- Battery room for UPS should have ventilation with full exhaust.
- Duct-board ductwork is leaking air into ceiling spaces.
- Older Fisher Steam PRVs/controls need replacement.

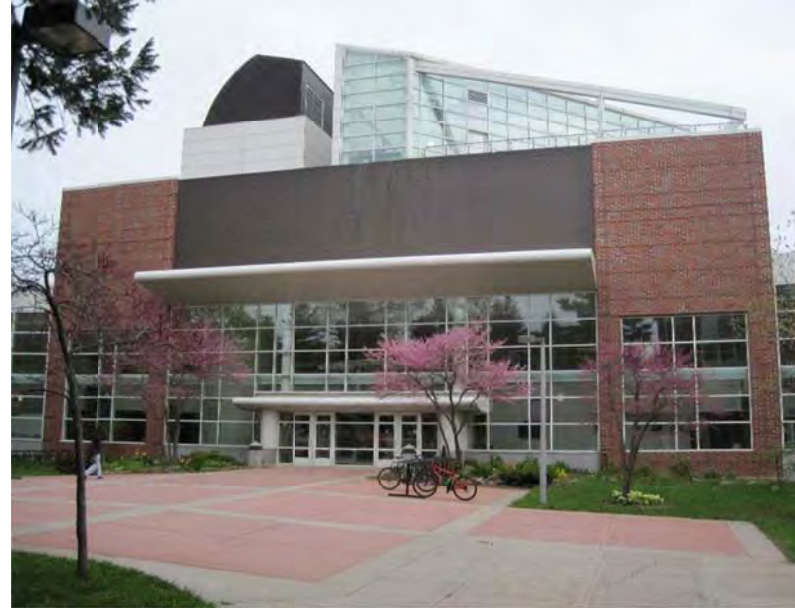
- Rubber nosing on stairs is at End of Useful Service Life.
- Provide power operated door switch.
- Medical-grade air compressors are at 10,000 run-time hour lifespan and require rebuild. Confirm with manufacturer's representative.

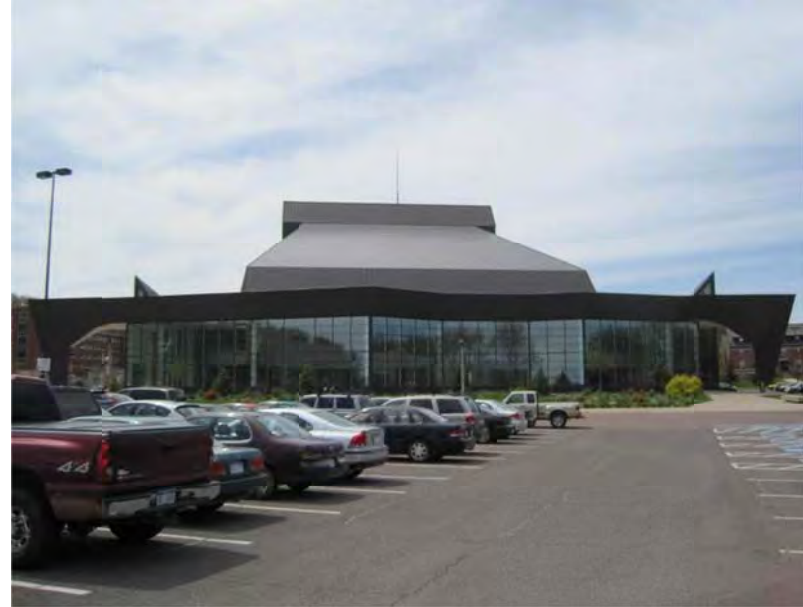
- Settling of brick in south west corner near areaway.
- Recently replaced 26 - 27 insulated glass panels due to leaking gaskets.
- History of water damage in main lobby. Roof has been repaired.
- G002 finned tube radiation is not covered and has been damaged from objects placed against it.

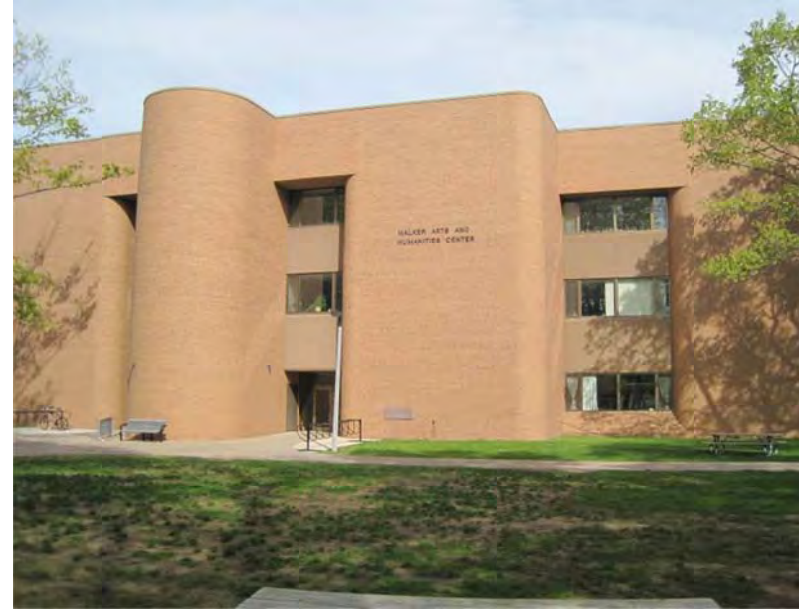
- Porous brick selected for exterior of building. Degradation of brick in several areas near grade. Replace broken brick and tuck-point where necessary.
- 40% of 2x2 suspended ceiling system near End of Useful Service Life.
- VCT in south corridor on main floor is beyond End of Useful Service Life.
- Water fountains not compliant.
- Interior finishes on levels 2/3 are at End of Useful Service Life. Classrooms are due for modernization to continue top instructional delivery.
- De-watering sump pump cord is connected to convenience outlet. Permanent AC power connection for de-watering sump should be provided.

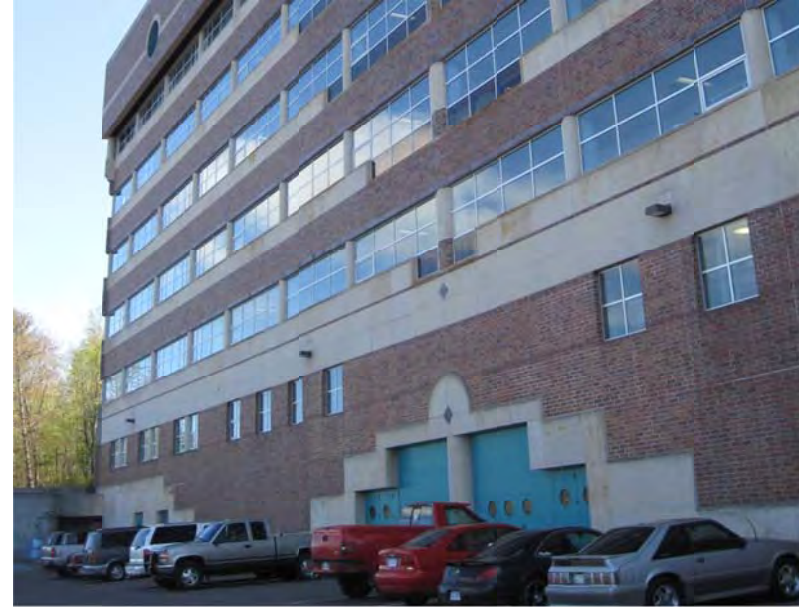
- Original roofing leaking. End of Useful Service Life.
- Membrane at parapet is not adhering and causing membrane to billow in many areas.
- Some windows are leaking.
- Degradation of sand stone coping.
- Excessive staining of sand stone on south elevation below windows.
- Exterior sealant joints at stone and brick are near End of Useful Service Life.
- Collision damage of sand stone at south east entry. Replace or repair damaged sand stone.
- VCT is not adhering well to corridors. Several chips in tile caused by high foot traffic and movement of lab equipment. Consider alternative material for floor covering. End of Useful Service Life.
- Smoke purge fan for stair and atrium needed.
- New sock drain put in place at foundation wall on east to reduce water infiltration (appears ok now).

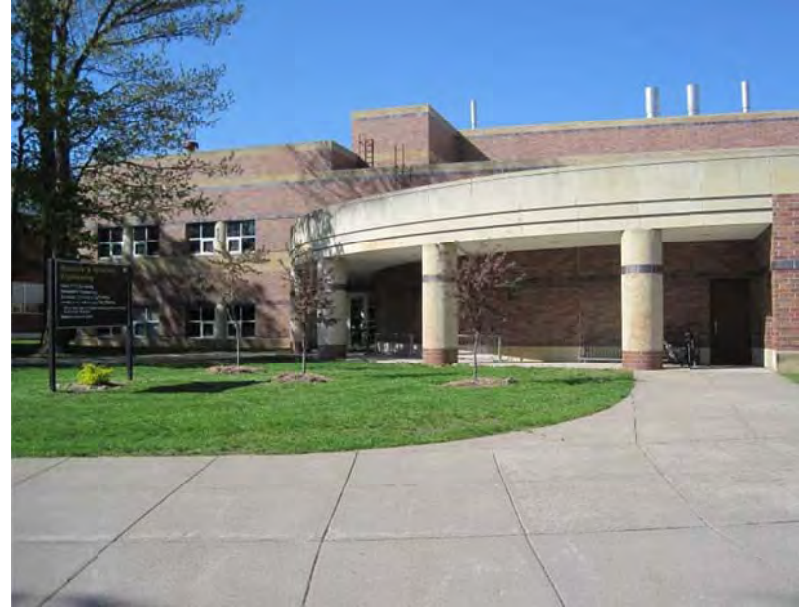
- Seating in U113 at End of Useful Service Life. Seating in U115 in poor condition.
- Rooms U113 & U115 are at End of Useful Service Life to maintain curriculum distribution at modern level.
- Provide lightning protection.
- Degradation of sand stone coping.
- Exterior sealant joints at stone and brick are near End of Useful Service Life.

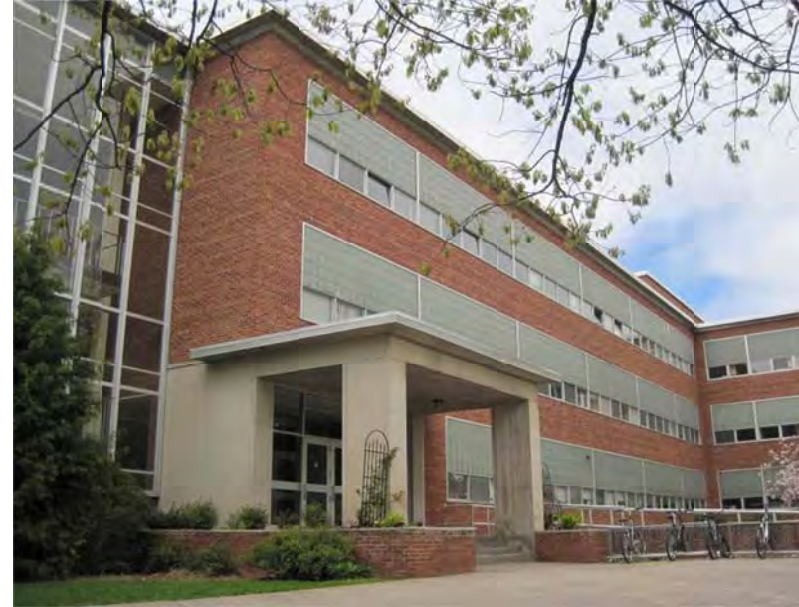
- Some settling of brick in NE corner above steam tunnel.
- Few leaks reported but nothing of concern.
- Air infiltration at frames throughout. End of Useful Service Life.
- Air and water infiltration at stairwells. End of Useful Service Life.
- Minimal re-pointing needed.
- Egress doors into stairwell open into the door closure of adjacent door. Provide alternate solution.
- Provide code compliant fire alarm system.
- Classrooms are due for modernization to continue top instructional delivery.
- Fire Alarm no horns or strobes.
- Large AHU is at End of Useful Service Life.
- Replace steam PRV station. Life expectancy per ASHRAE is 25 to 35 years.

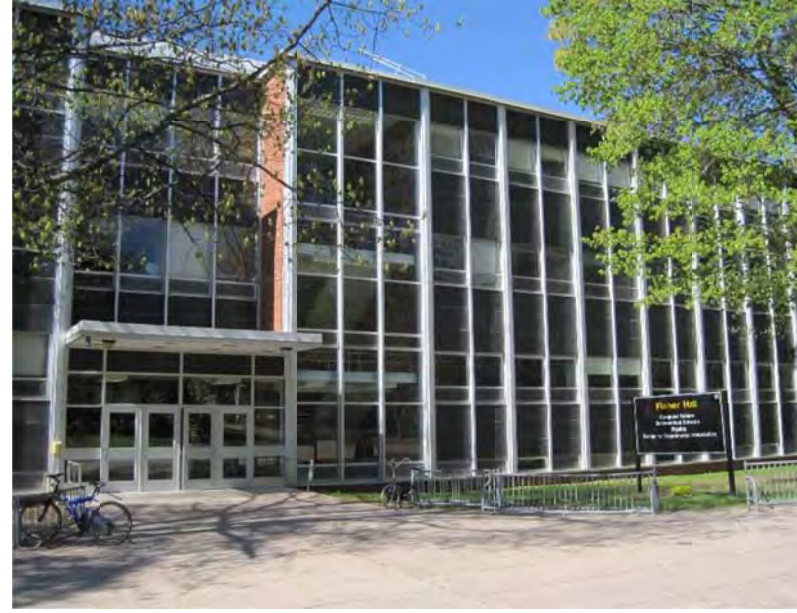
- AHU units are at End of Useful Service Life. ASHRAE life expectancy is 25 to 35 years.

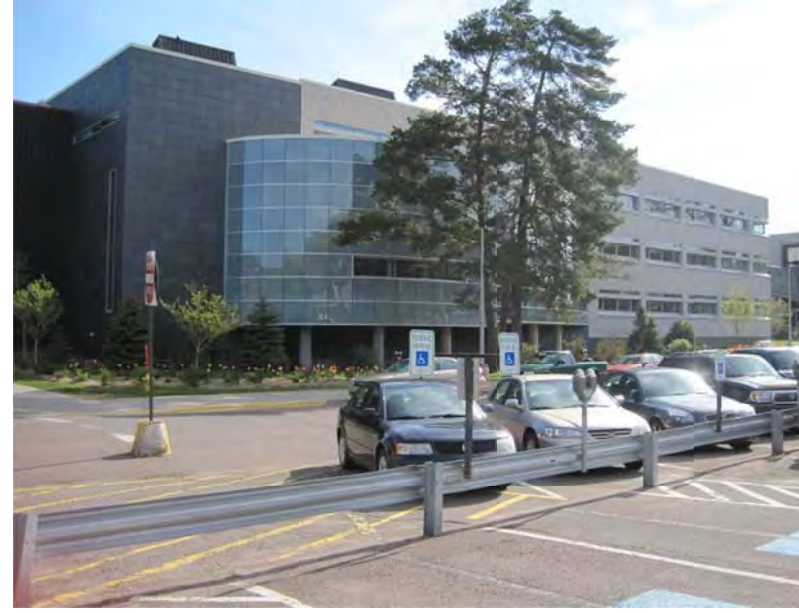
- Original Van Pelt AC-2 and AC-3 in Penthouse MER are at End of Useful Service Life. ASHRAE life expectancy is 25 to 35 years.

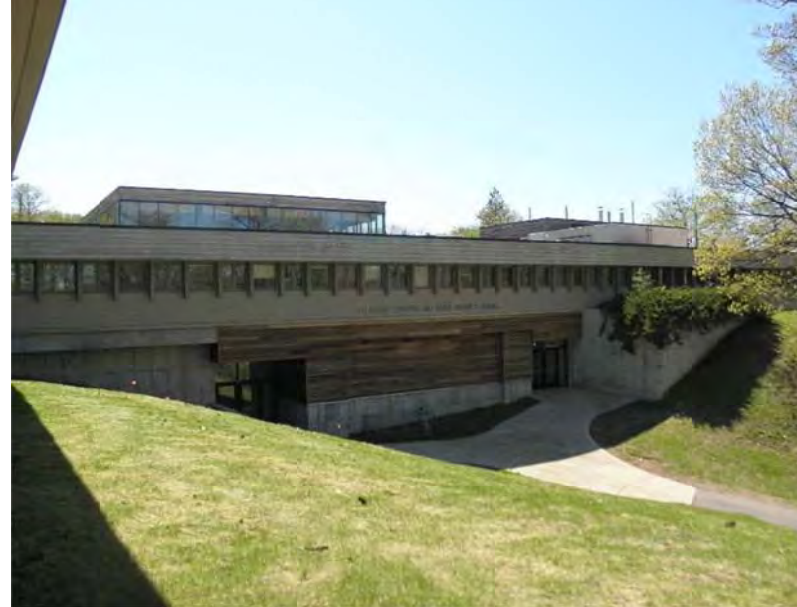
- AHUs should be replaced in next 5 years in older part of the building. ASHRAE life expectancy is 25 to 35 years.

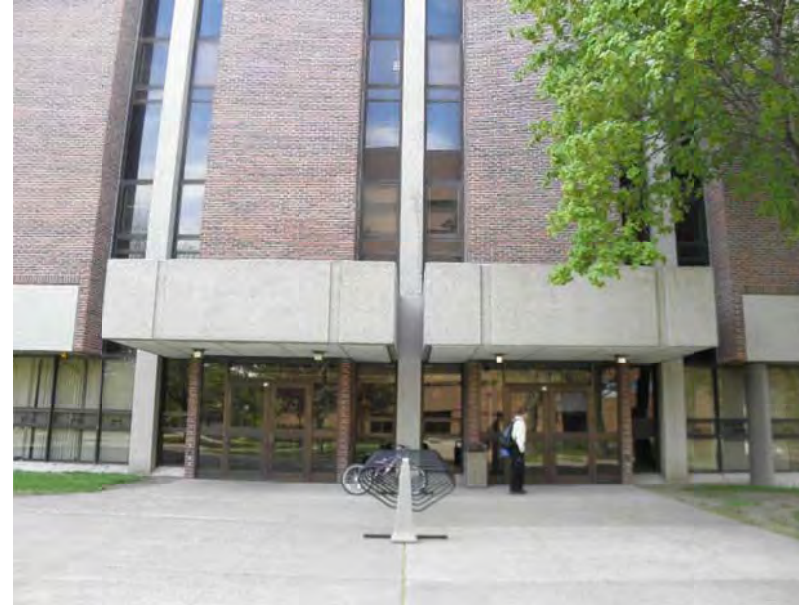
- Need to replace Federal Pacific switchboards-switches starting to fail.
- Chiller should be replaced original. Humidifiers in penthouse need to be replaced-leaking, HV-3 needs to have filters installed, and cooling tower needs to be replaced.

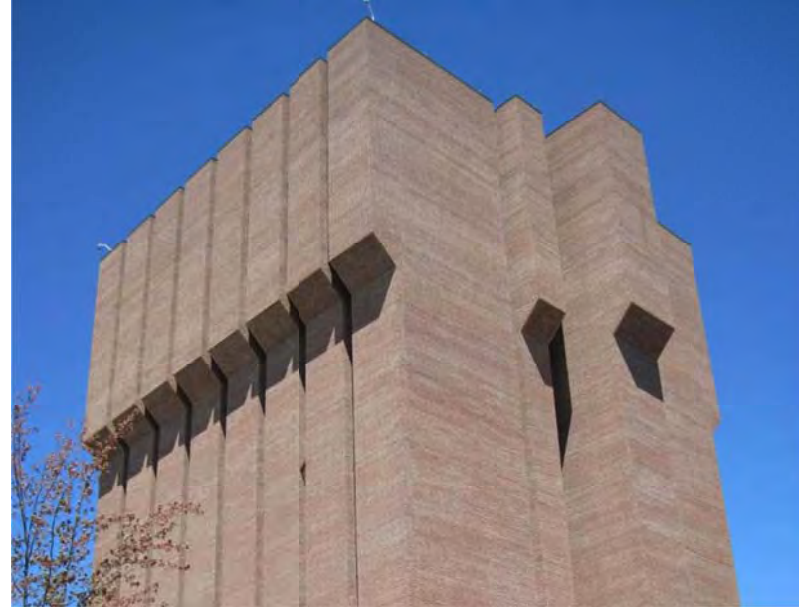
- Windows on the east and west elevations leak with driving rain. Window system near End of Useful Service Life.
- KARR report on exterior façade maintenance recommendations is attached for reference.
- Some tuck pointing necessary.
- Bottom of overhead door freezes to the floor in winter. Provide alternative solution.
- Replace T12 fixture with T8. Re-ballast and add lamps.
- SF-2 belts were loose and belt guard not in place.

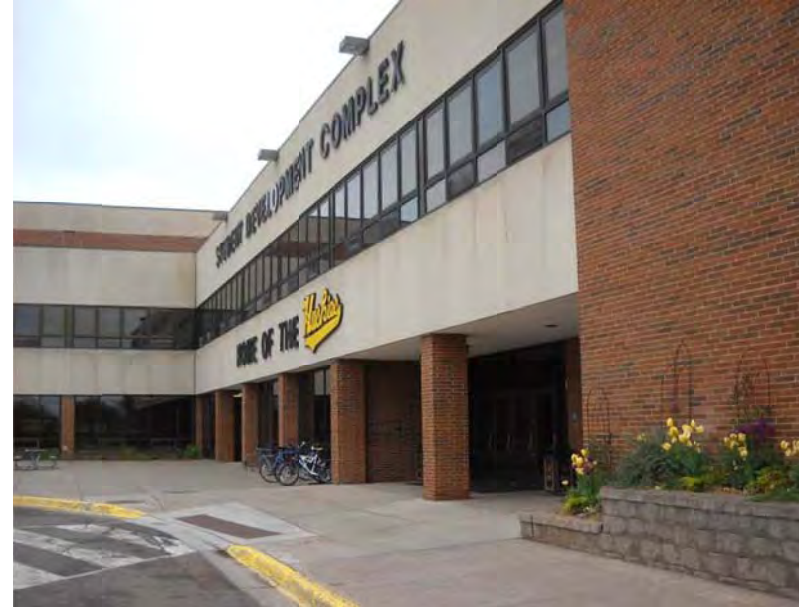
- The existing pool equipment is 15 years old and is near the End of Useful Service Life.
- The ice arena concrete slab and the refrigeration system, at the End of Useful Service Life.

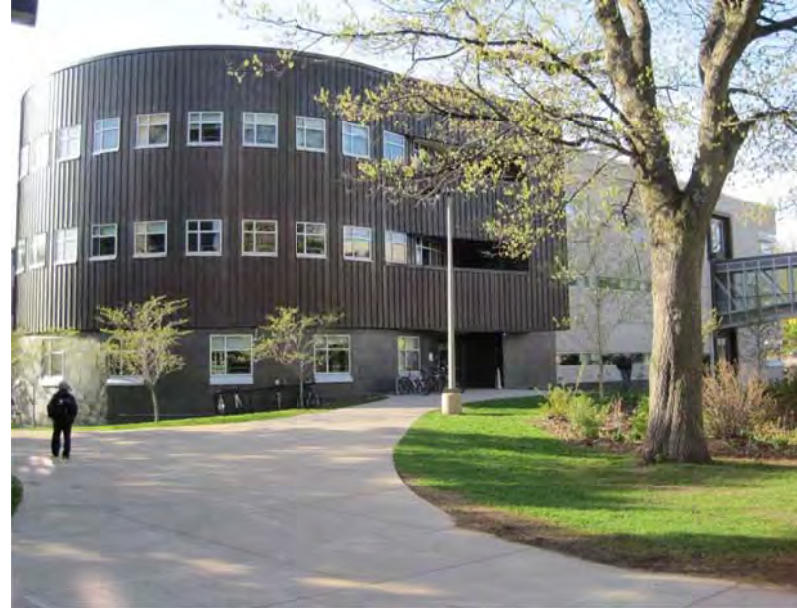
- Hollow metal door at connection to Fisher does not close properly. Replace rated assembly to meet code compliancy.
- Solid core doors with hollow metal frame in entry lobby leading to office suite are not rated assemblies.
- Overhead fire shutter on third floor is potentially dangerous. Shutter is located more than 3' from window and could potentially entrap someone in event of emergency.
- VCT over raised floor in server rooms is delaminating and may become tripping hazard. Provide alternative floor cover system in server rooms. System at the End of Useful Service Life.
- Doors at 100A are not code compliant.
- Door into office suites from corridor 100, 200 or 300 are not code compliant.
- Basement VAVs in main corridor were never balanced or commissioned properly due to inaccessibility. This may contribute to noise problem in the Distance Learning space.

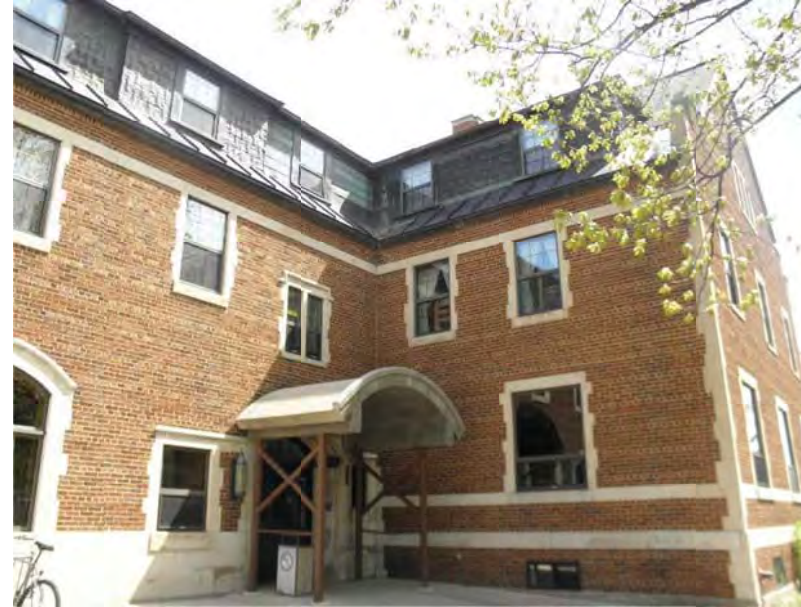
- Replace old Square D panels and switches.
- Weight room has no ventilation.
- DW and sanitary are in poor shape and need to be replaced, storm sewer tied into sanitary, backflow preventers used.

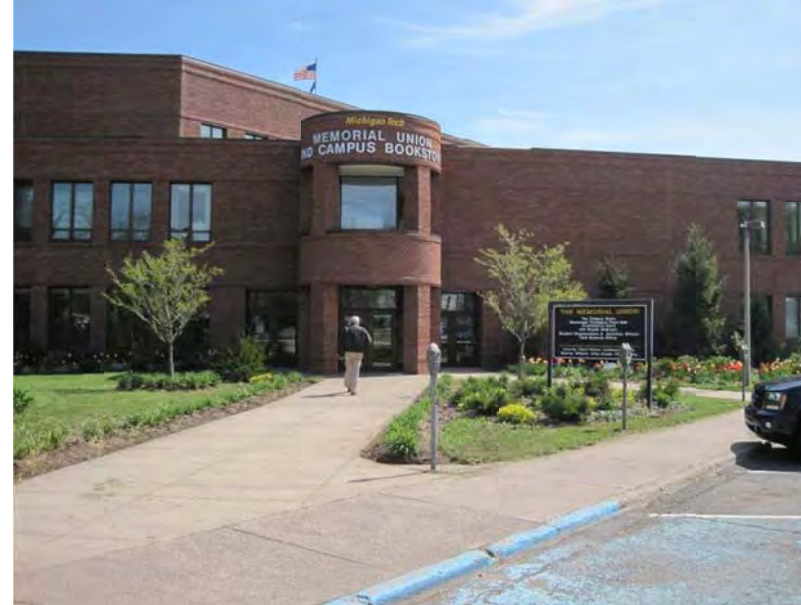
- Water fountain not compliant.
- T12s should be replaced with T8s in most fixtures.
- 1/3 – 2/3 PRV steam piping needs re-insulation.
- City water back flow preventer is leaking to floor drain.

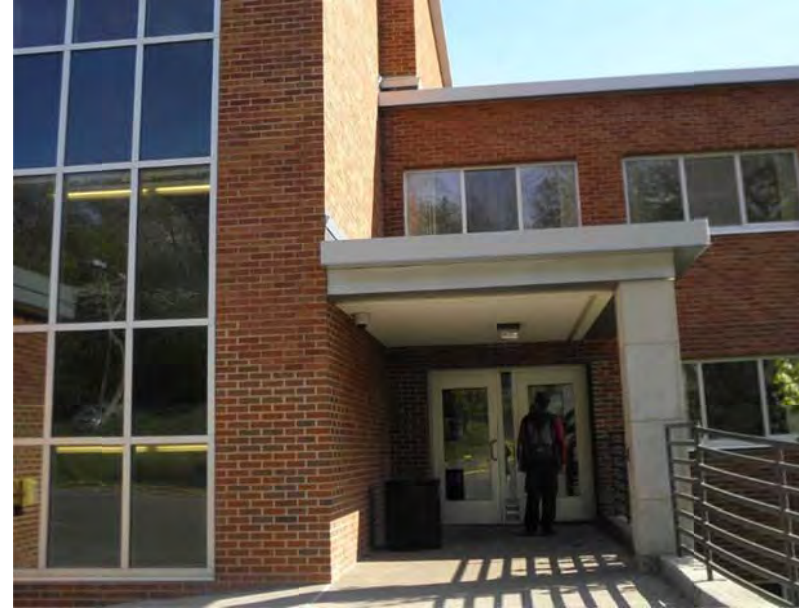
- Replace original Square D panel boards.
- Remove lights over stairs and replace with pendant fixtures with lower devices.
- Hot water heating main zone valve needed, no shut off valves installed to isolate system.

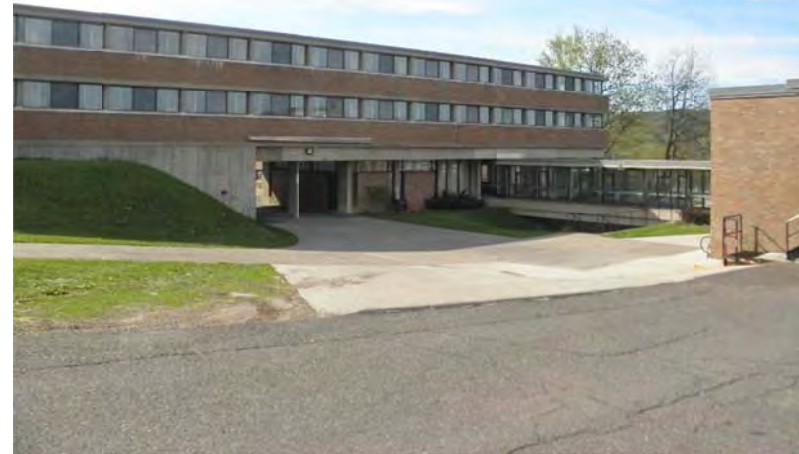
- Large-sized non-tempered insulated and single glazed units are safety hazard. Replace all non-tempered glazing units (Activities Area).
- Original plumbing.
- No ventilation in restrooms at levels 1 and 2.
- Open coping joints due for repair.
- Water infiltration at single glazed windows reported. Window system at the End of Useful Service Life.
- Architectural repair in (40) stall showers for replacement of mixing valves.
- Site re-grading necessary to the south to divert water away from the building.
- Unsafe trash chute.
- Labeling of electrical panels is bad. Check loads in panel and label with correct loads.
- Need to replace and increase size of exhaust fans for gang toilets.
- Pneumatic system has leaks.

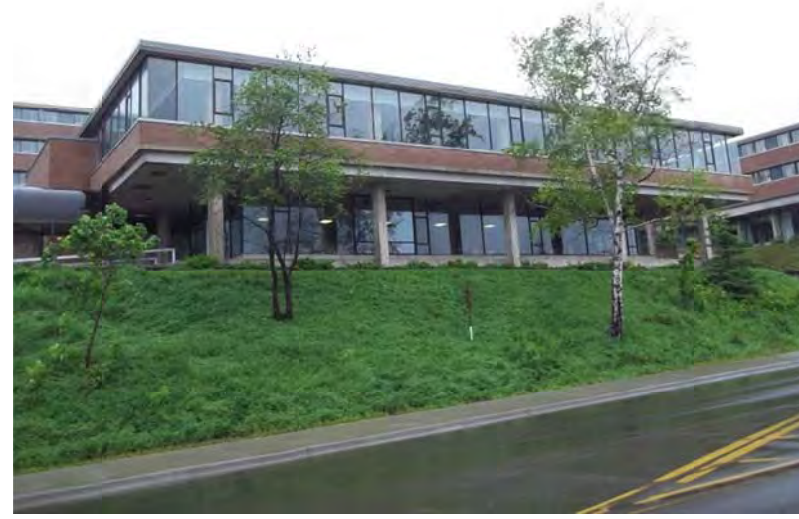
- Provide GFCI outlets for all outlets without ground wires.
- Refrigeration piping above ceiling in Dining is leaking.

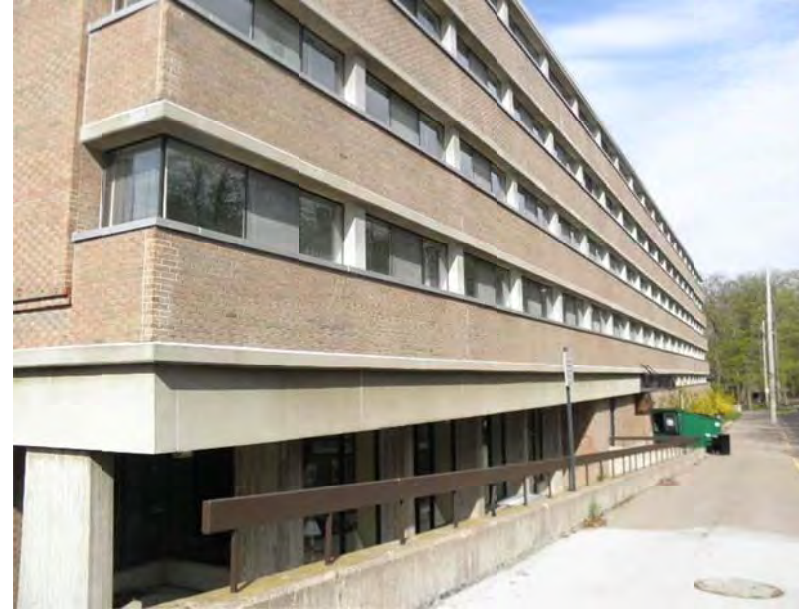
- Original plumbing.
- Toilet rooms along main corridors are quite tight (non-accessible) and overused with inadequate ventilation.
- Radiators along perimeter walls typical at residential units.
- Glazing system at the End of Useful Service Life.
- Large spans of non-tempered glazing, potential safety hazard.
- Damage observed at brick veneer. Repair as needed.
- Gypsum board ceiling is delaminating in restrooms due to humidity.
- 2x2 suspended ceiling system at activities room and lounge is near End of Useful Service Life.
- Unsafe trash chute.
- Labeling of panels is bad.
- Check loads in panel and label with correct loads.
- Replace all shower mixing valves, replace DW piping and sanitary.
- Gang toilet room humidity problem.
- Need to replace and increase size of exhaust fans for gang toilet.

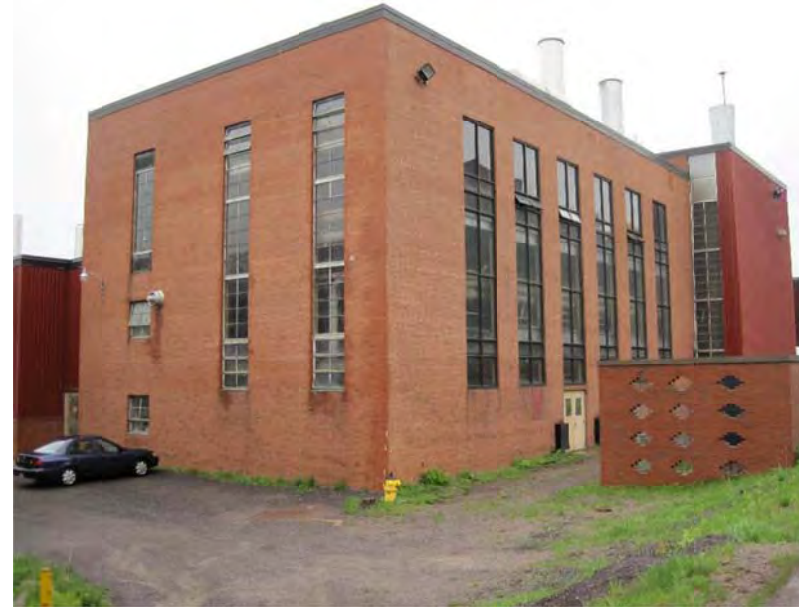
- Upgrade and add code compliant horns and strobes.
- **Operational efficiency, reliability, and safety issues are noted in an internal Michigan Tech report provided in the Appendix.**

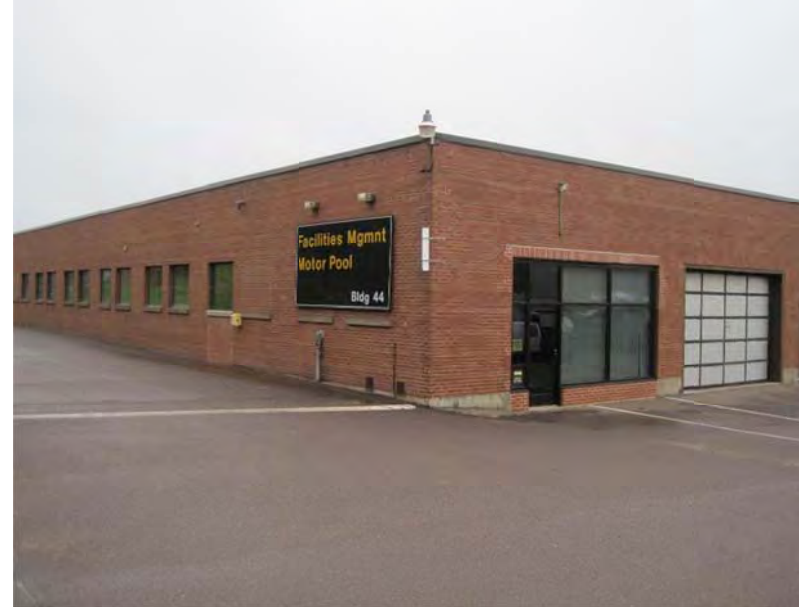
- 50% of roof is not draining properly.
- 30% of roof drains clogged. Clean drains.
- Steel window frames at End of Useful Service Life.
- All sealant at steel window frames is beyond End of Useful Service Life.
- Minimal re-pointing needed in brick.
- Sealant at expansion joints on exterior cladding is beyond End of Useful Service Life.
- Overhead door into 105 is beyond End of Useful Service Life.
- Provide code compliant fire alarm system.
- Wood framed mezzanine may not be compliant.
- Water flowing toward overhead door on east elevation. Re-grade slope to repel water.
- Upgrade and add code compliant horns and strobes.
- Heat exchanger in Car Wash area should be insulated.

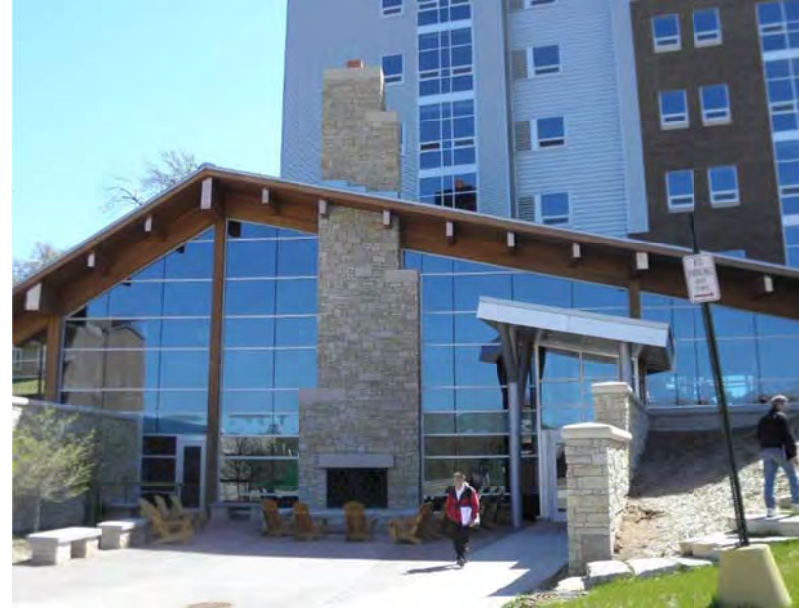
- Building is fully air-conditioned.
- At similar areas around the building, the through wall metal flashing appears to be improperly installed. i.e. the drip edge is bent at non-constant angle between floors 3 & 4 at the north elevation. The flashing does not extend far enough out beyond the face of the brick veneer. Repair is required.
- Some exterior building joints are improperly installed at south elevation at precast window sills. Repair and replace as necessary.

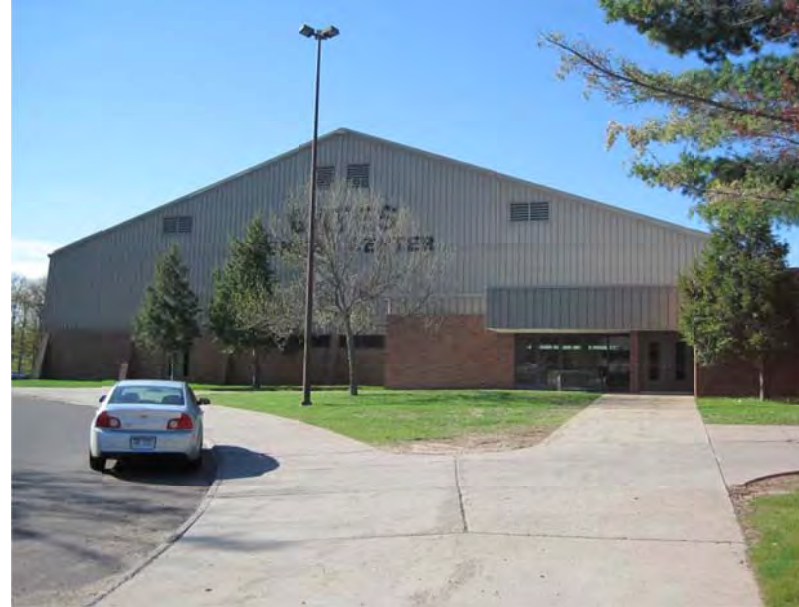
- Water penetration at NE exterior wall.
- Provide lightning protection.
- Where brick slopes away from building, water infiltration is causing sprawling and brick failure. Provide alternate solution.
- Some collision damage in brick. Replace and repair large openings and broken brick.
- Corrugated metal leaks with driving rain.
- Sagging suspended ceiling tiles in locker rooms and showers. At End of Useful Service Life. Replace with hard ceiling.
- Due for re-painting.
- Carpet is dirty. Near End of Useful Service Life.
- Water infiltration at west elevation. Re-grade to redirect flow of water.
- Add additional Egress lights.
- Add horns and strobes.
- Heating hot water pumps and piping are missing insulation.
- Insulation on PRV valve and piping is missing

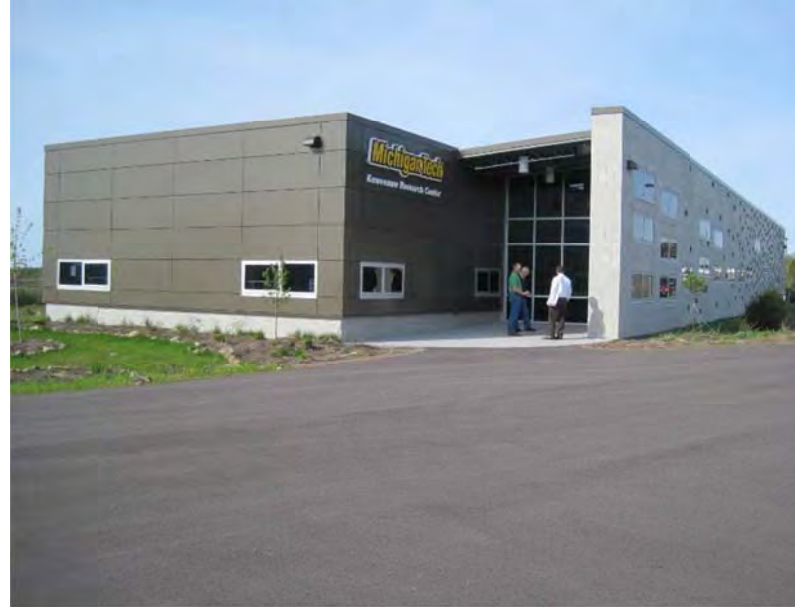
- No overflow drains at flat roof.
- The hollow metal door with hollow metal frame at the high bay space needs sealant around frame at CMU. Provide sealant where necessary.
- Piping through janitor's closet and receiving dock office ceiling is not fire sealed. Remediate.

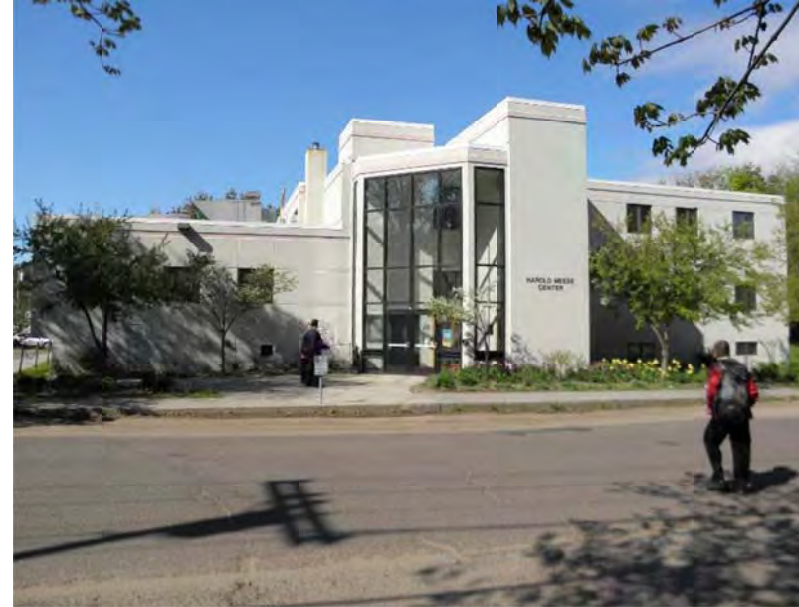
- Extensively remodeled and completely repurposed in 1996.
- It was reported that sprinklers discharged (in the past) and the carpet was not dried. Carpet is damaged. There is a “foreign” smell throughout the building.
- No ventilation at entry (Feels excessively hot).
- Window hardware is malfunctioning, due for repair.
- EIFS deterioration, damage and cracking observed around the perimeter of the building. Open sealant joints between panels. Due for repair.
- Multiple EIFS panels are damaged probably due to sprinkler discharge near north west corner. Due for Replacement.
- Carpet at offices and corridor on second level is End of Useful Service Life.
- Make-up air units 15 years old and due for replacement.

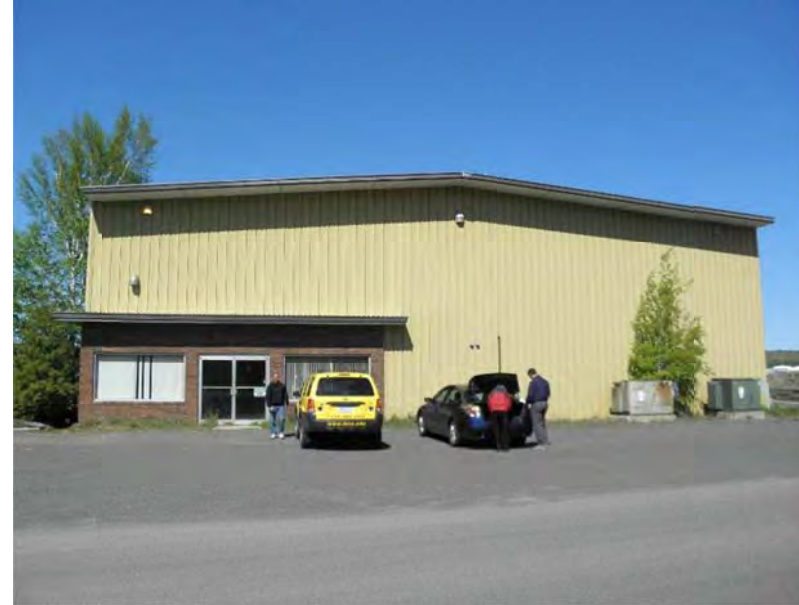
- Pre-engineered buildings typically have a life expectancy in the range of 40-years. Structure is approaching the End of Useful Service Life.
- Damaged panels observed. No flashing at base of metal siding. Due for repair.
- All exterior sealant joints are at End of Useful Service Life. Some fasteners at metal siding are deteriorating.
- Hollow metal doors with hollow metal frames due for re-painting.
- Composite sectional overhead doors at End of Useful Service Life.
- Provide fire alarm system.
- Replace fixture with T8 HO strips.

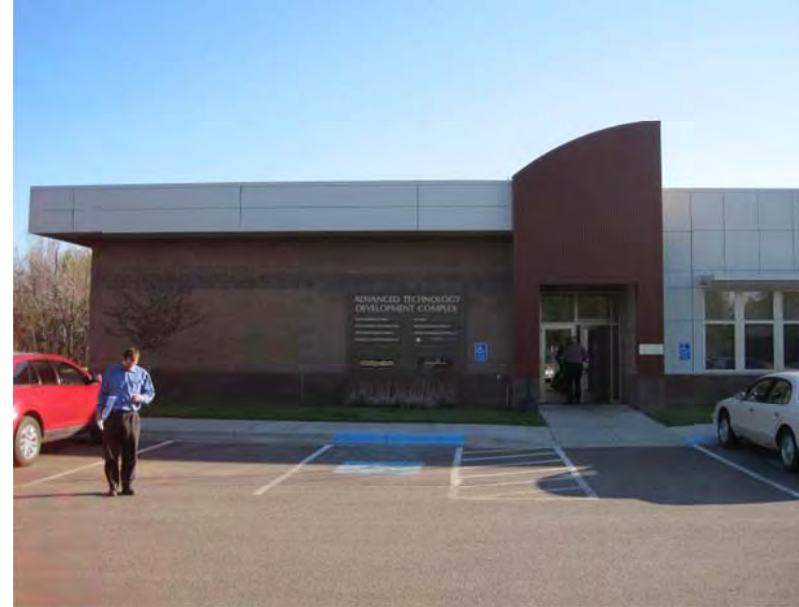
- No fire protection or fire stopping in storage rooms.
- Update exit signage and emergency lighting per code requirements.
- Piping and ductwork through mezzanine walls into tenant spaces are not fire sealed. Remediate

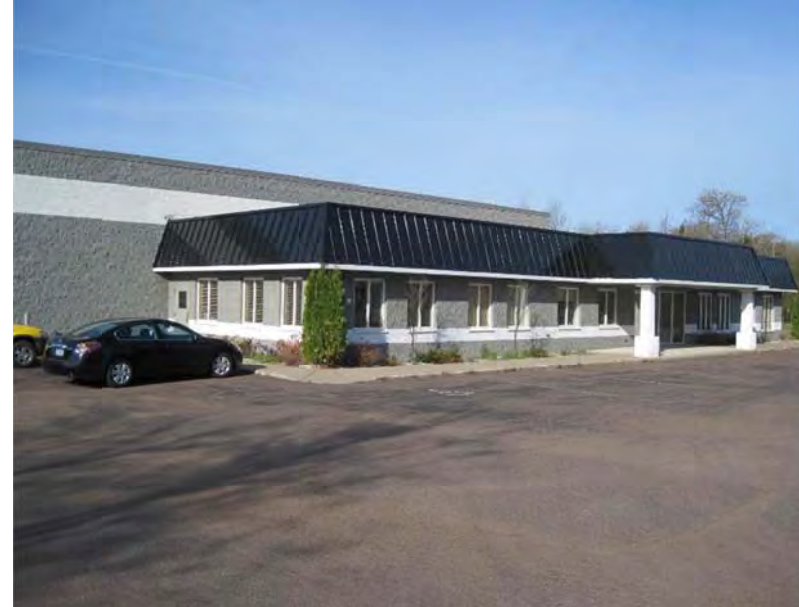
- In general warehouse is aging predictably.
- All finishes in 101A are at End of Useful Service Life.
- Most office finishes are aging predictably.
- Non insulated CMU in warehouse causing thermal bridging, moisture infiltration, and deterioration of block especially at horizontal bond beam.
- Flashing on warehouse at parapet is coming loose.
- VCT in break room is stained and cracking. Beyond End of Useful Service Life.
- Travel distance to means of egress in warehouse is compromised with addition. Provide compliant means of egress.
- Non complaint exiting in warehouse, new exit doors required.
- Doors from mezzanine to warehouse have no fall protection.
- Windows between original warehouse and new addition are not rated.
- Internal access from office to warehouse is non-compliant.
- No horns or strobes noted.
- Add strobes and horns.

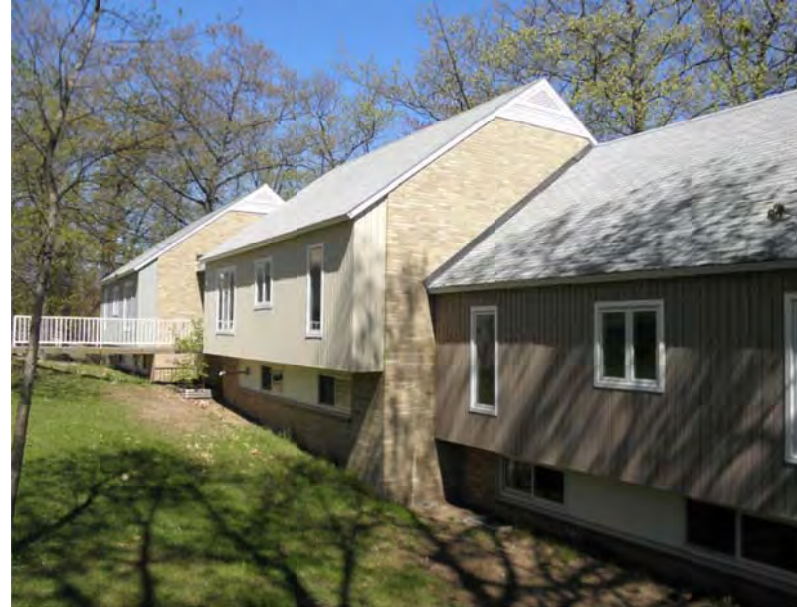
- The existing 4" sanitary running from the building to the main line is in poor shape and should be replaced.

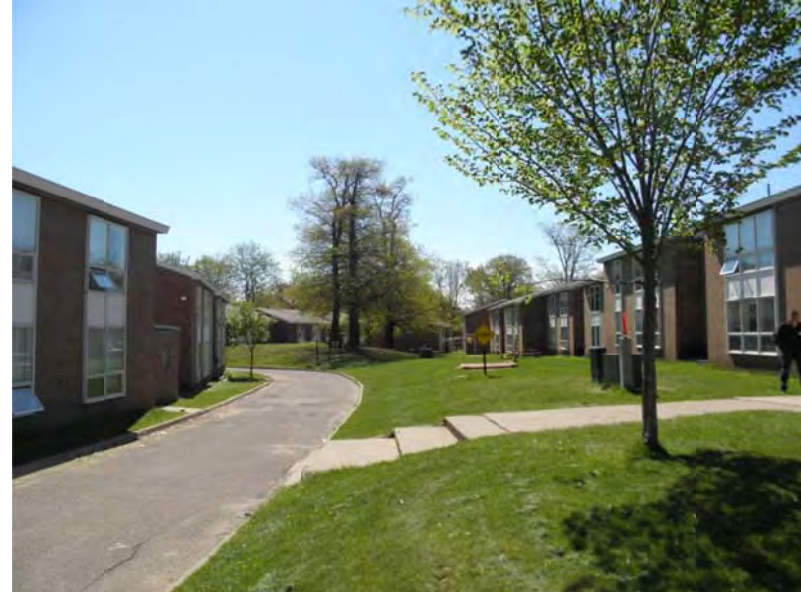
- Daniel Heights Apartments (Upper Heights) consists of 13 Duplexes.
- The storage space at each building houses the boilers which is a safety concern. Moreover, if during the winter months the storage door is left open, the domestic water heaters freeze.
- Original (1968) double pane operable awning aluminum frame windows at End of Useful Service Life. Aluminum frame is falling apart, showing condensation and the lack of thermal break.
- Replace 50% of kitchen cabinets (metal) with new plastic laminate cabinets and plastic laminate countertops (both base cabs and wall cabs).
- Exterior doors showing heavy wear and damage. Doors are at End of Useful Service Life.
- Provide egress lighting outside of units.
- The existing 4" sanitary running from the building to the main line is in poor shape and should be replaced.

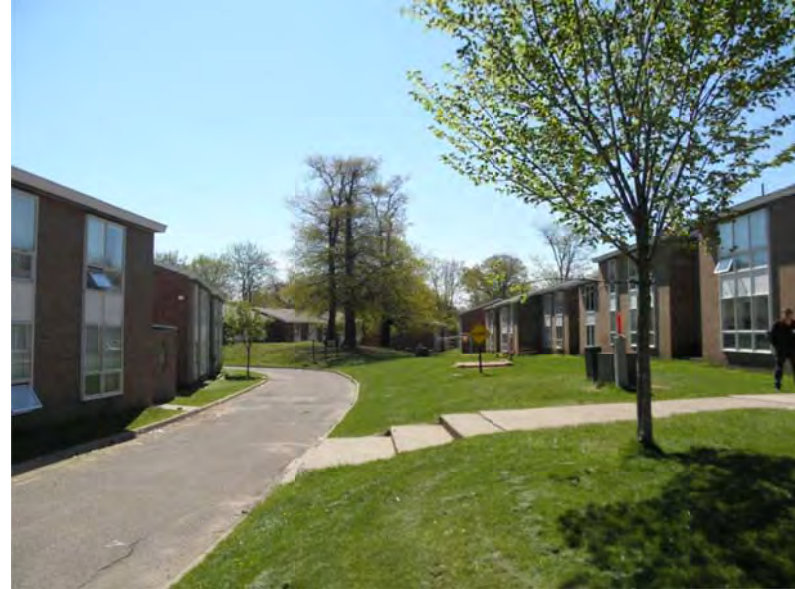
- Daniel Heights Apartments (Upper Heights - Addition) consists of 13 Duplexes.
- The storage space at each building houses the boilers which is a safety concern. Moreover, if during the winter months the storage door is left open, the domestic water heaters freeze.
- Original (1968) double pane operable awning aluminum frame windows at End of Useful Service Life. Aluminum frame is falling apart, showing condensation and the lack of thermal break.
- Replace 50% of kitchen cabinets (metal) with new plastic laminate cabinets and plastic laminate countertops (both base cabs and wall cabs).
- Exterior doors showing heavy wear and damage. Doors are at End of Useful Service Life.
- Provide egress lighting outside of units.
- The existing 4" sanitary running from the building to the main line is in poor shape and should be replaced.
