## FACILITIES ASSESSMENT AND DEFERRED MAINTENANCE CAPITAL PLANNING REPORT

2011

SHWGROUP

SHW Group, in conjunction with the Michigan Technological University Facilities staff, performed a high-level facility condition assessment of all campus buildings in May 2011.

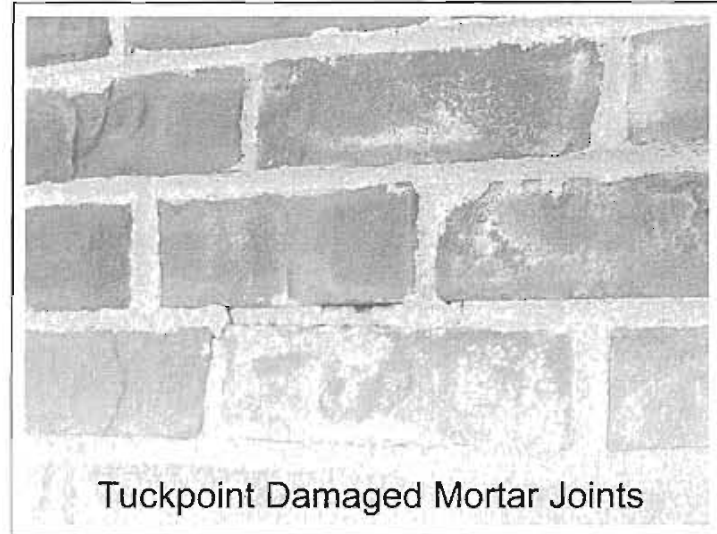
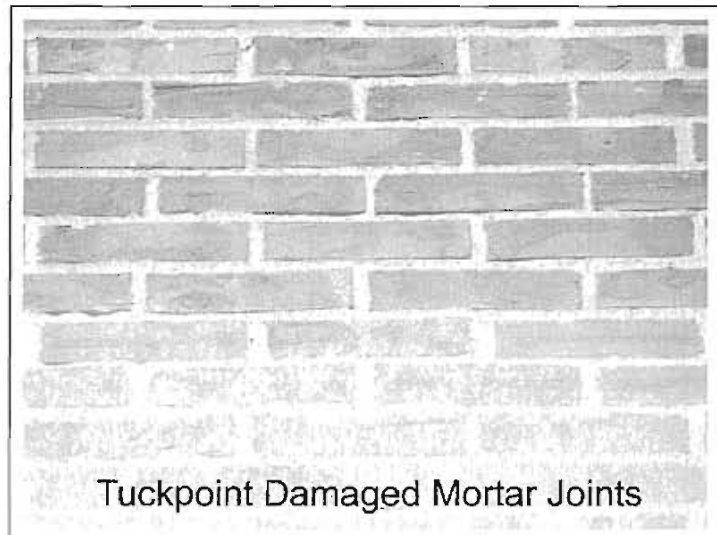
There are few defective joints in the masonry that were visible during the masonry inspection. Following the power washing process, we are now able to closely inspect the masonry surface. Defective joints will need to be tuckpointed so the building can be weatherproof.

**REPLACE 20 MISSING OR DEFECTIVE BRICK UNITS**

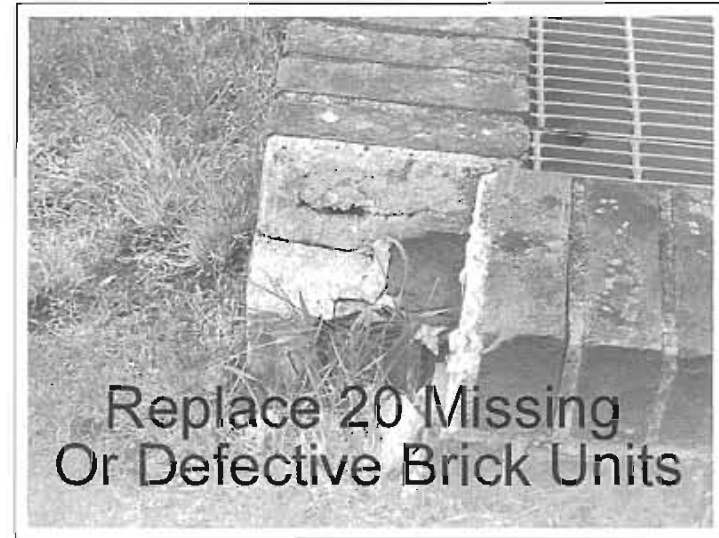
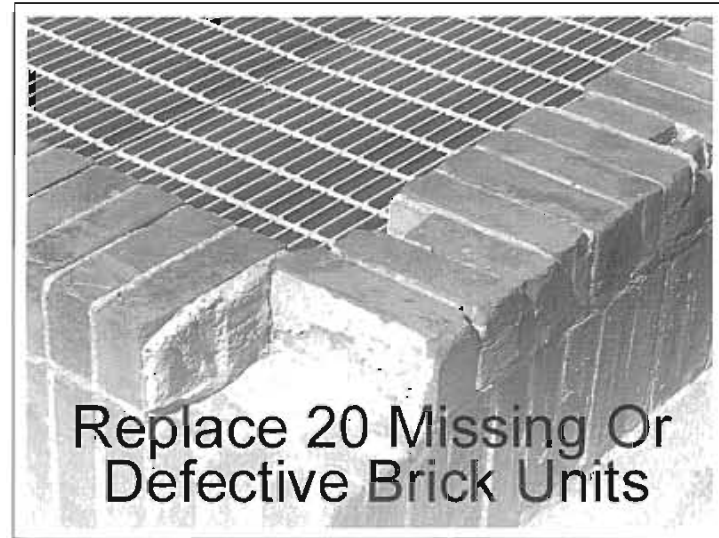
Moisture enters the face of the brick units by capillary action from open mortar joints and/or defective caulking joints. When present in sufficient quantity and for an extended time, this moisture will freeze and cause the face of the brick to spall. When one brick becomes defective, if not corrected, more brick in this area will also become defective.

## SEAL MOVEMENT CRACKS

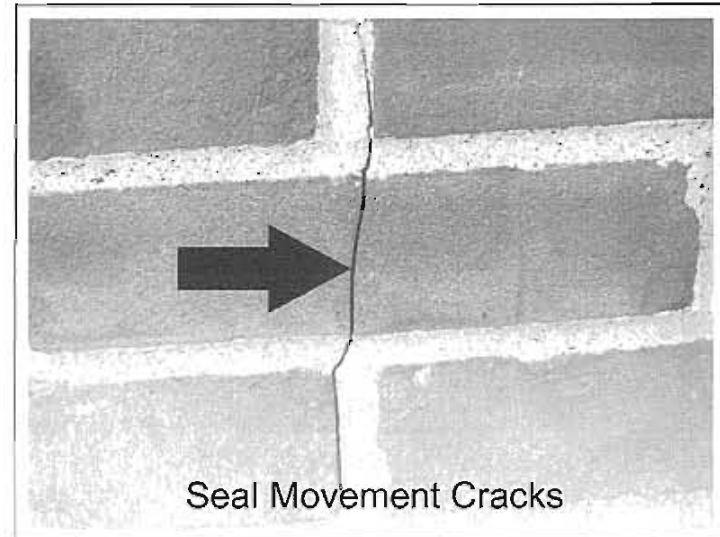
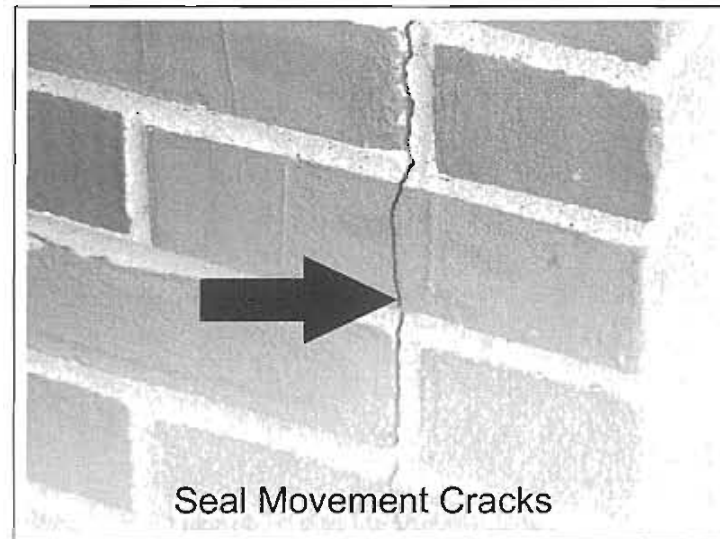
Masonry like all building material expands and contracts due to temperature changes. Clay brick absorbs moisture and expands permanently. Control joints should be used to control changes in height and/or thickness near openings. If the wall is built without control joints or not enough joint movement due to temperature or moisture changes will cause the wall to crack.

**INSTALL FLEXIBLE CAULK AROUND THE PERIMETER OF THE WINDOWS, DOORS AND VENTS**
