## FACILITIES ASSESSMENT AND DEFERRED MAINTENANCE CAPITAL PLANNING REPORT

2011

SHWGROUP

SHW Group, in conjunction with the Michigan Technological University Facilities staff, performed a high-level facility condition assessment of all campus buildings in May 2011.

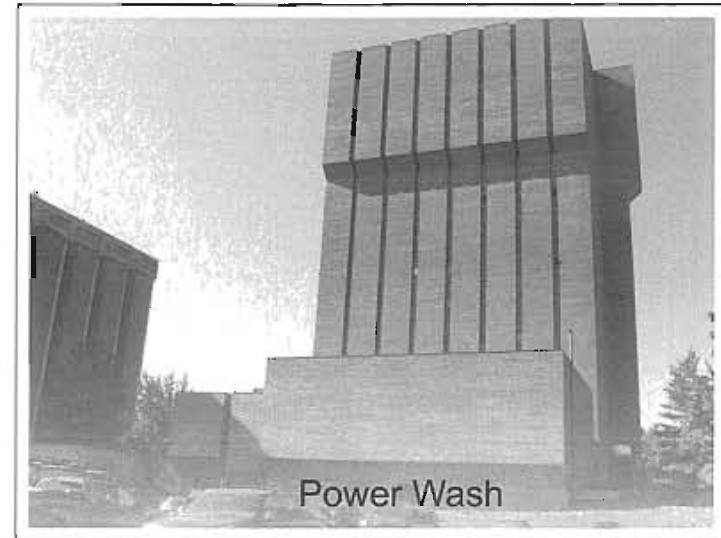
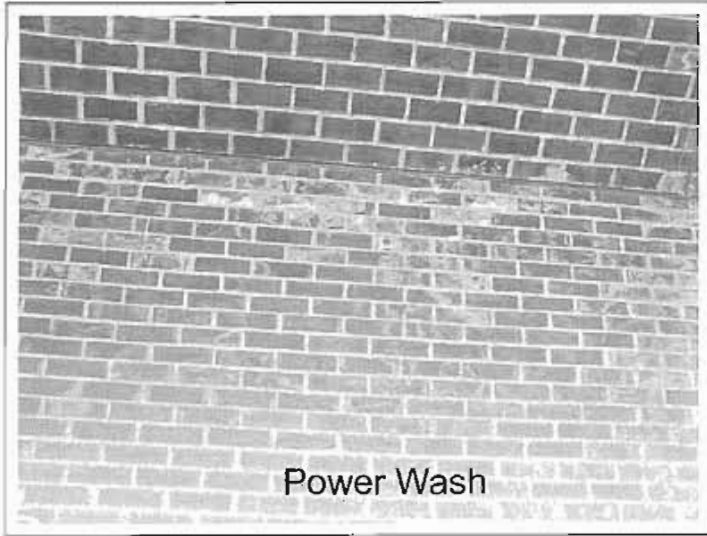
The purpose of power washing is not to change the general appearance of the building but to remove the surface dirt to expose any defective joints in the area.

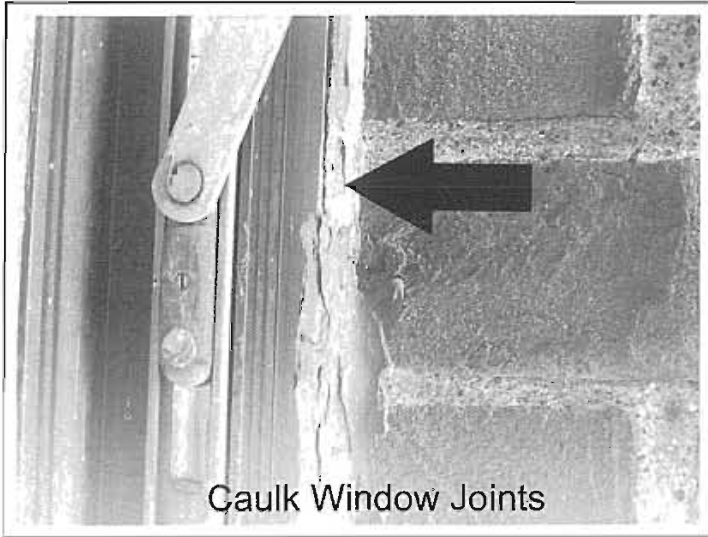
Caulk Window Joints

Windows, doors and vents are installed in the masonry wall after the masonry walls are completed. When the units are installed, there remains a joint between the installed unit and the masonry of the various widths. When this joint has not been previously caulked or becomes defective, not only is the moisture allowed to penetrate the building, and it also becomes difficult to control your heat and air conditioning costs.

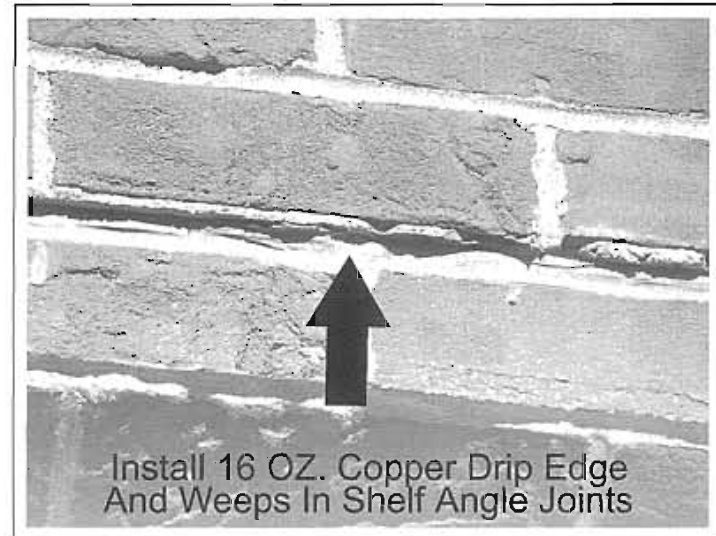
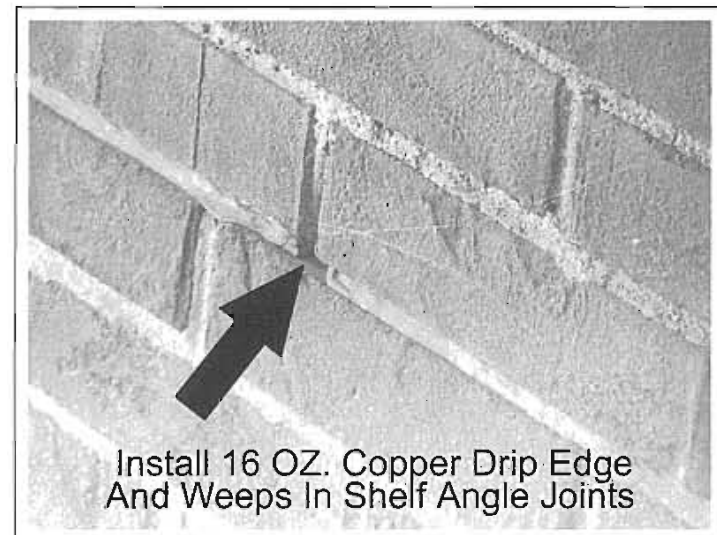
### INSTALL 16 OZ. COPPER DRIP EDGE IN SHELF ANGLE JOINTS

When the lintels are caulked, the caulk prevents moisture from escaping from the lintel joint. The trapped moisture will cause the lintel to rust. The rust will expand causing the lintel to fail to support the masonry unit above it. The system outlined above will allow the moisture to escape from the top of the lintel and prevent the moisture from damaging the interior surface of the structure.

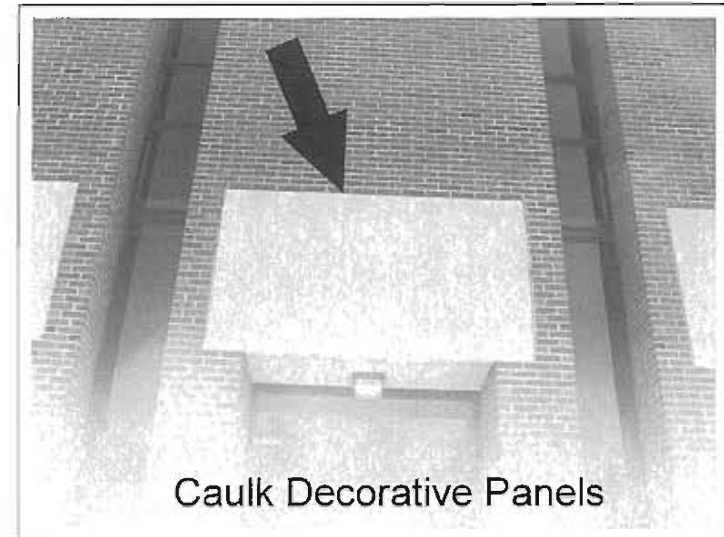
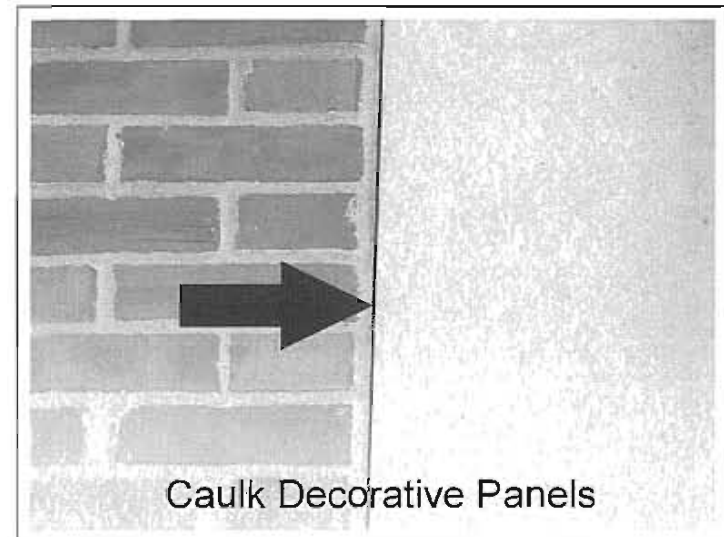
## INSTALL FLEXIBLE CAULK AROUND THE PERIMETER OF DECORATIVE PANELS

When the units are installed, there remains a joint between the installed unit and the masonry of the various widths. When this joint has not been previously caulked or becomes defective, not only is the moisture allowed to penetrate the building, and it also becomes difficult to control your heat and air conditioning costs.

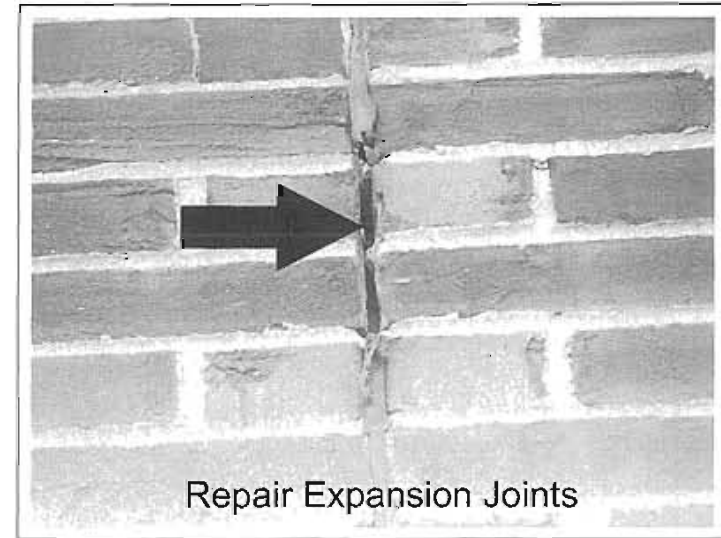
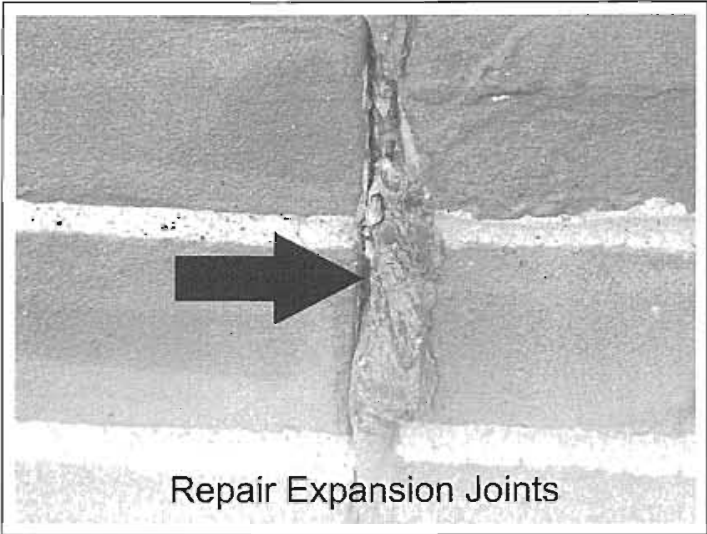
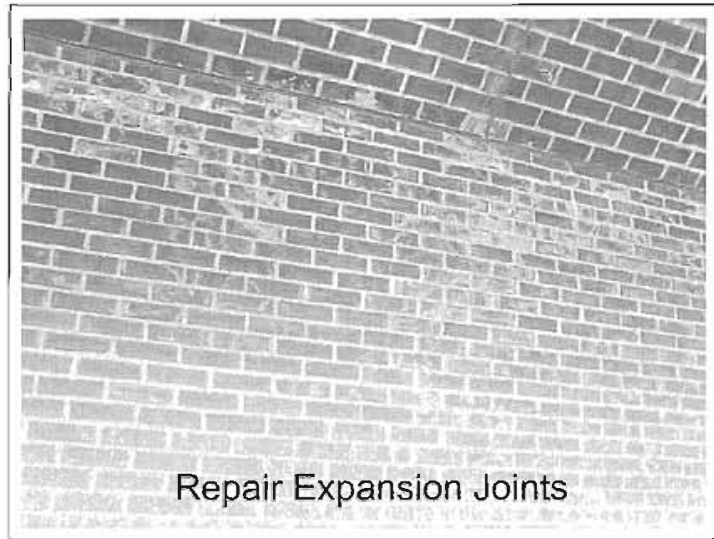
## REPAIR EXPANSION JOINTS

The masonry units shrink over a period of time, and if this movement is not restrained by the design, excessive cracking can occur. Expansion joints are continuous, vertically weakened sections between masonry units. When stress occurs, cracking will develop. The cracks will occur at the designed joints and allow moisture to penetrate the masonry units. The expansion joints must be sealed against weather with a flexible caulk because of the constant state of movement.

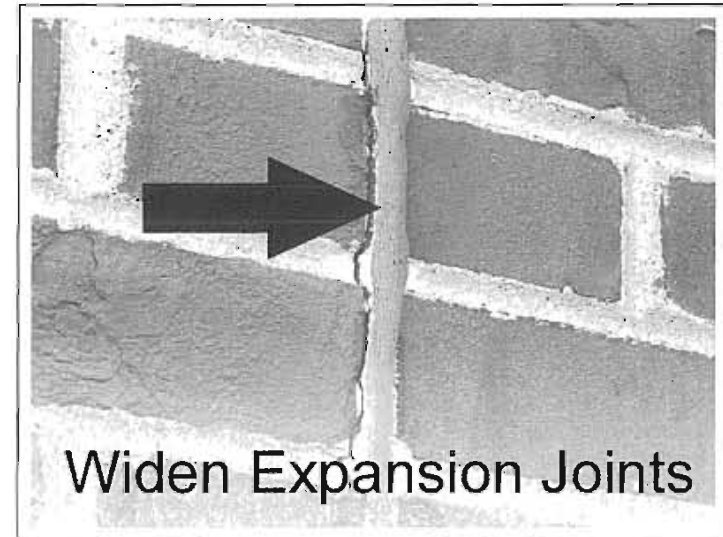
### WIDEN EXPANSION JOINTS THAT ARE UNDER 1/2" IN WIDTH

The masonry units shrink over a period of time, and if this movement is not restrained by the design, excessive cracking can occur. Expansion joints are continuous, vertically weakened sections between masonry units. When stress occurs, cracking will develop. The cracks will occur at the designed joints and allow moisture to penetrate the masonry units. The expansion joints must be sealed against weather with a flexible caulk because of the constant state of movement.

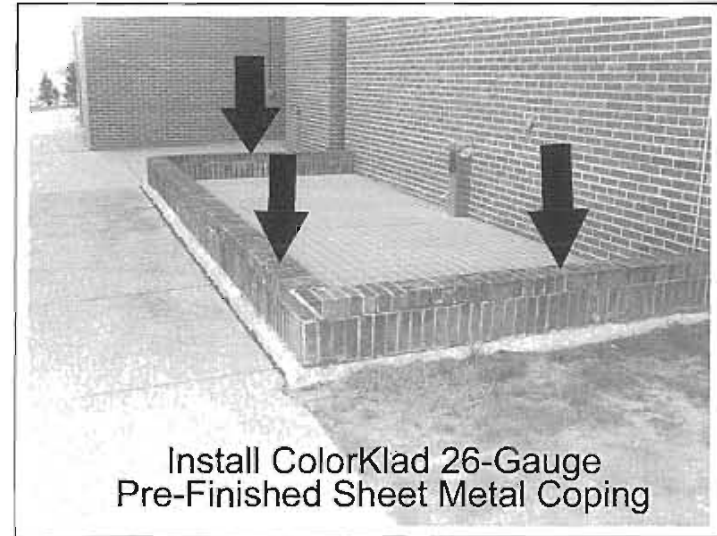
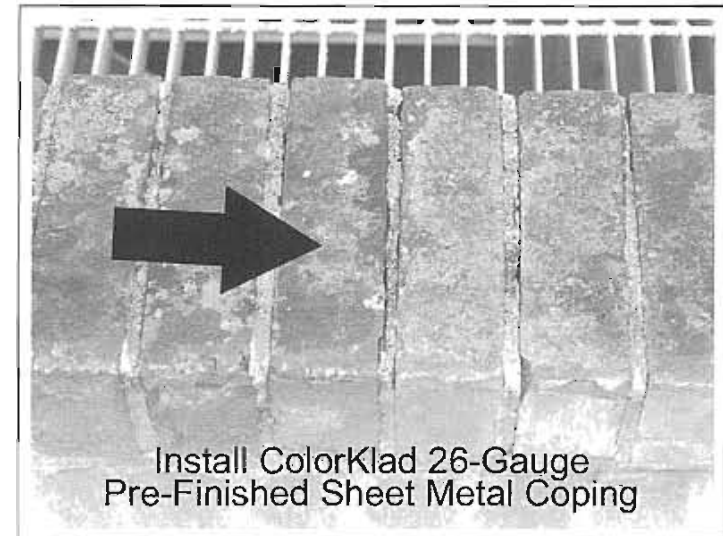
**INSTALL COLORKLAD 26-GAUGE PRE-FINISHED SHEET METAL COPING ON WINDOW WELLS**

Brick is not a suitable material to use for a coping on a masonry wall. When brick is used we have far to many joints that allow water to enter the masonry and over time the freeze and thaw cycles cause the wall to deteriorate. When a stone or metal coping is applied, the joints are caulked and sealed to prevent water from entering the masonry unit below and also allows for expansion of the masonry wall.
